Roseau River Watershed District
March 2020 Management Plan Amendment
Appendix 14: Supplemental Amendment

1.0 Introduction - background and summary.

**Roseau River Watershed District
Drainage Ditch Inventory and Inspection (SEDLCP) 2014
Site Identification and Prioritization Project
Grant ID – C14-8525**

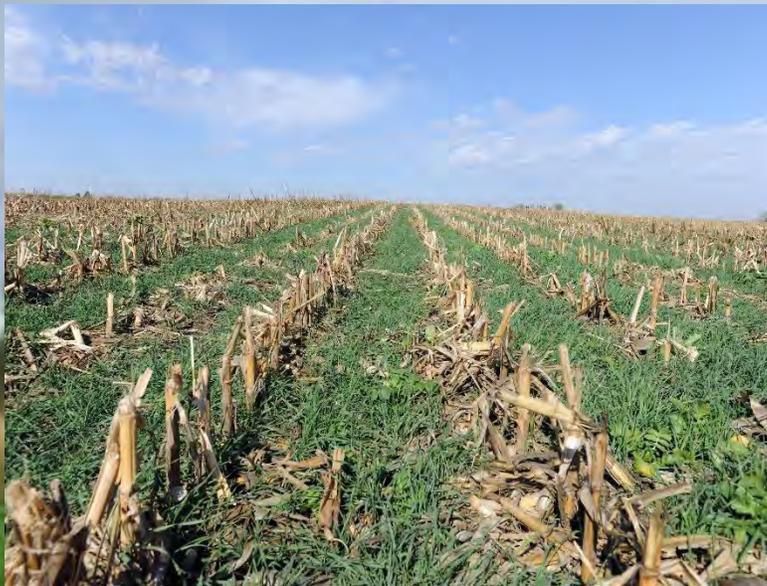
Cover Crops

Cover crops are herbaceous plants grown alongside annual cash crops to provide seasonal soil cover on cropland when the soil would otherwise be bare.

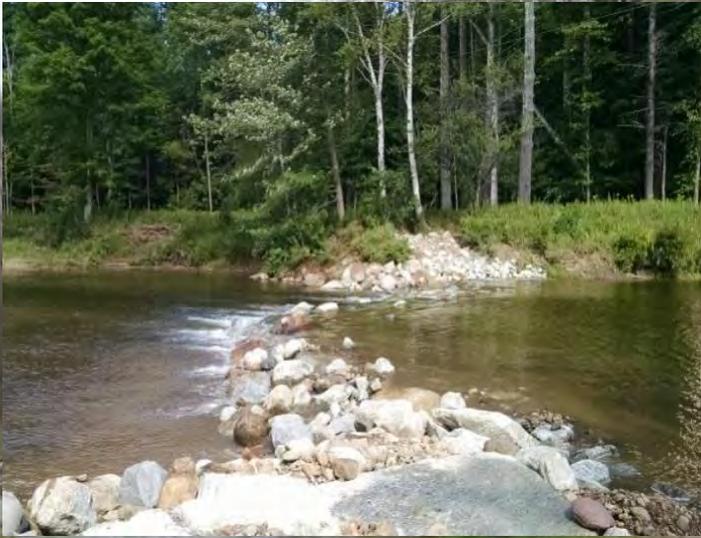
A Grade Control Structure is built within a natural or man-made channel, stream, grassed waterway, or gully to reduce channel bed erosion. Grade control structures are used at sites where the flow velocity or the concentration of water in a channel requires a structure to stabilize the grade or to prevent headwater cutting (erosion) from continuing upstream. These structures control stream flow passage through a sudden drop in elevation from one stable grade to another.

There are a wide variety of Grade Control Structures with high variability in designs and expense. Consult your local watershed district personnel for design/engineering support.
