ENGINEER'S REPORT

ROSEAU LAKE REHABILITATION PROJECT

ROSEAU RIVER WATERSHED DISTRICT

JUNE 2019

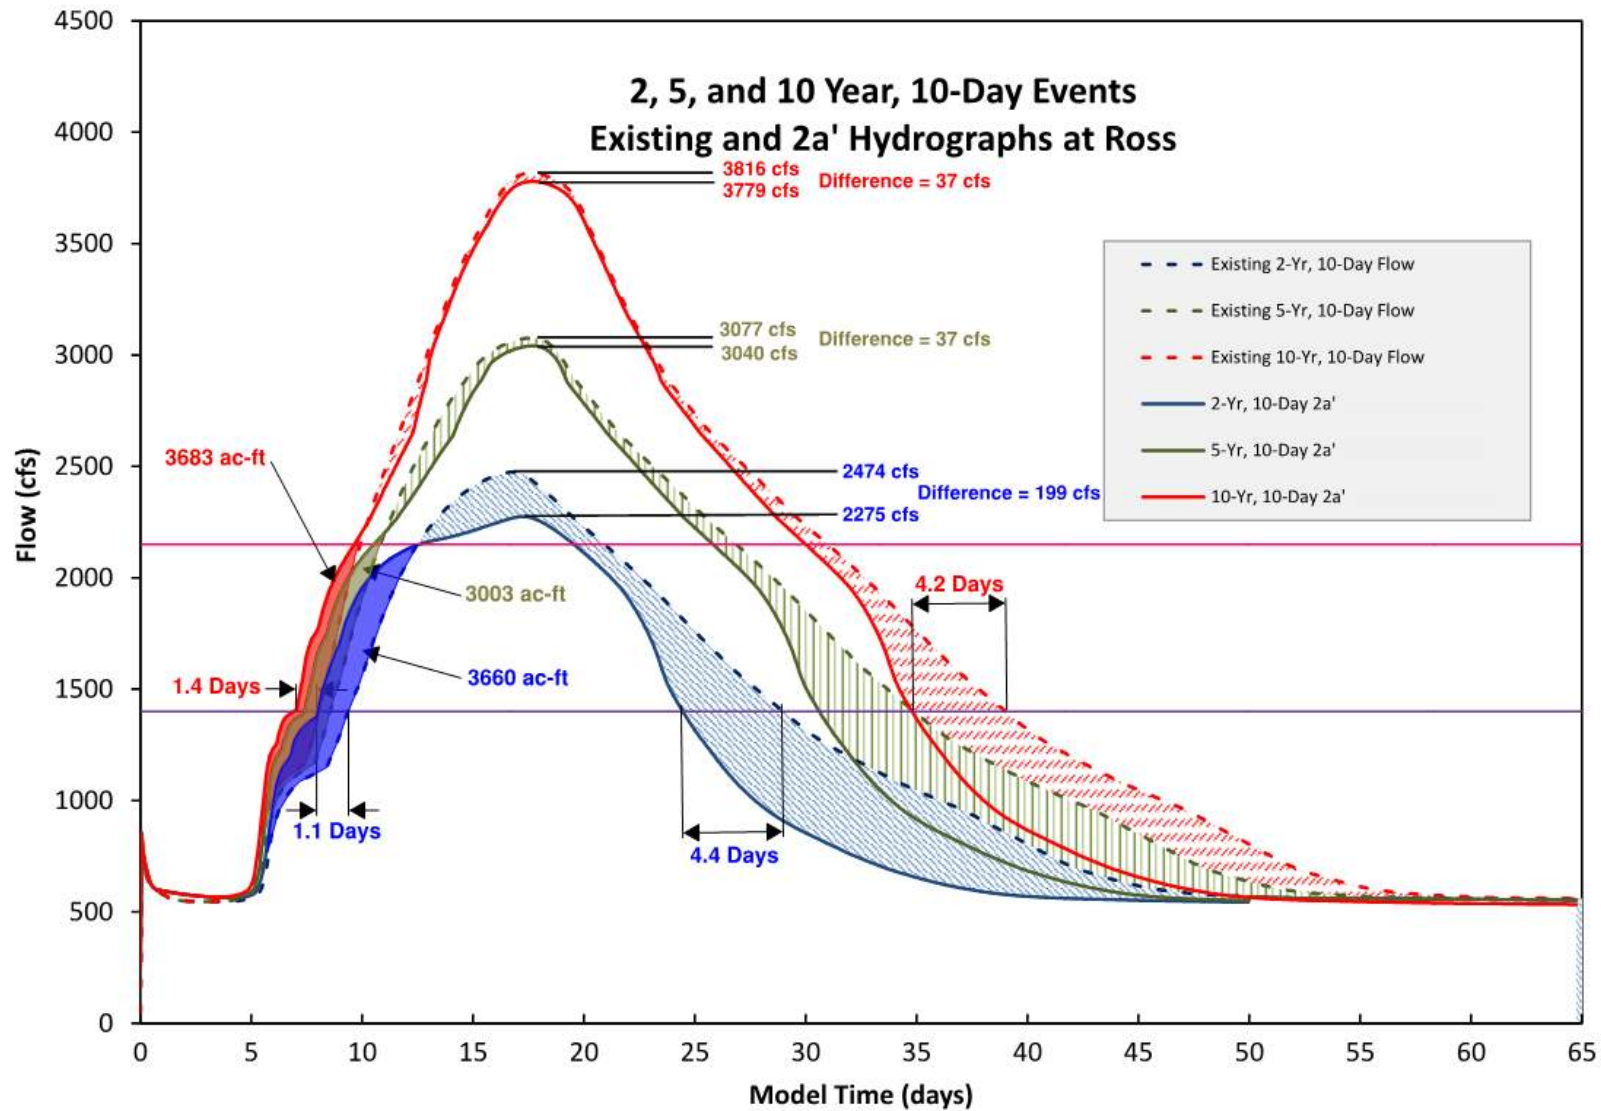
Figure 19. Existing Condition vs. 2a' Flow Hydrographs for the 2, 5, and 10-year 10-day events at Ross

Figure 19 shows the flow hydrographs for existing conditions and Alternative 2a' for the 2, 5, and 10-year 10-day events at Ross. The main pool begins to fill at hydrograph day 7 and is above the weir crest elevation of 1034 feet at hydrograph day 13 for the 2-year 10-day event. There is a peak flow reduction for the 2-year 10-day event of 199 cfs with increased benefits expected for slightly smaller events.

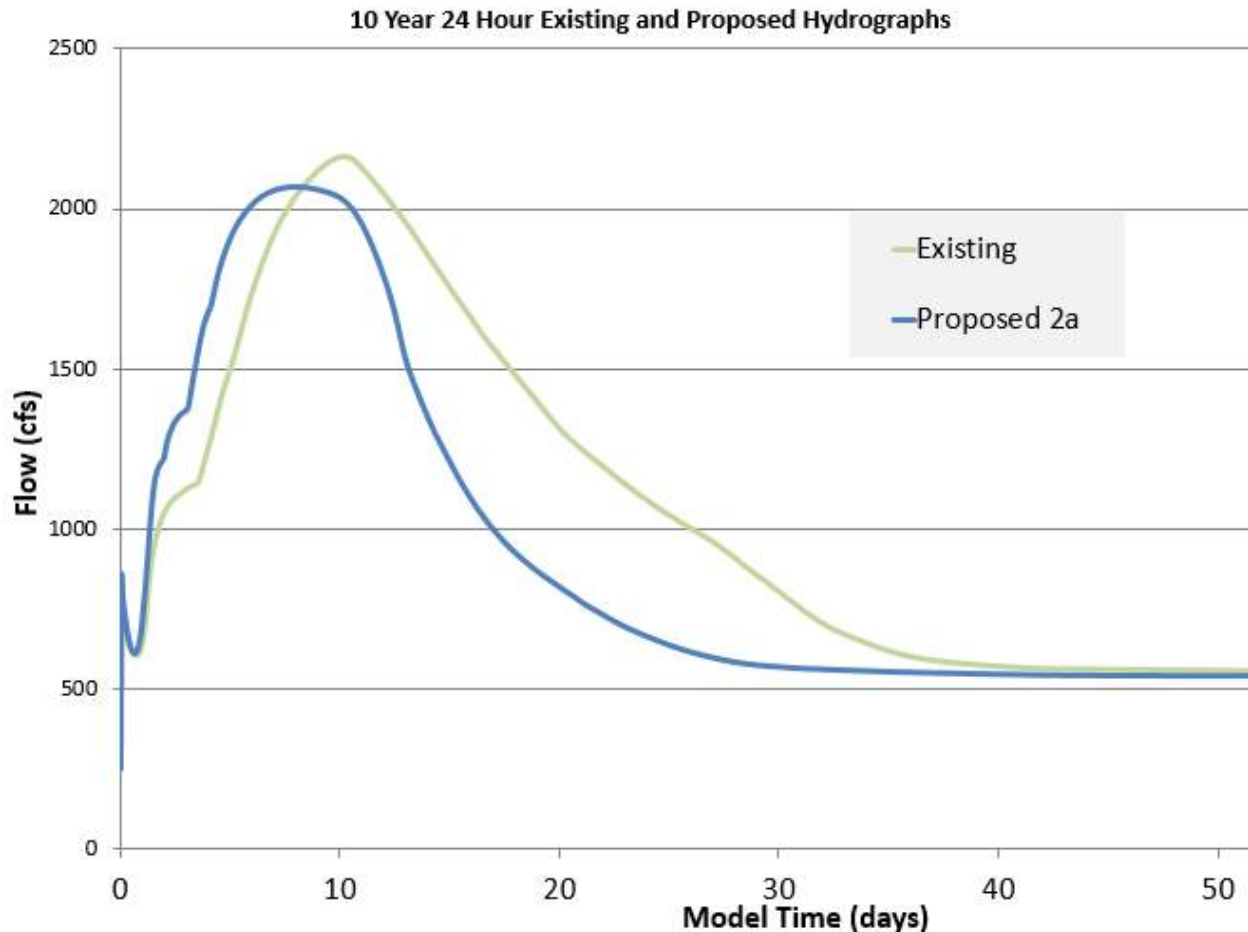
Figure 20. Existing Condition vs. 2a' Flow Hydrographs for the 10-year 24-hour events at Ross

Figure 20 shows the 10-year 24-hour flow hydrographs for existing conditions and Alternative 2a' at Ross.

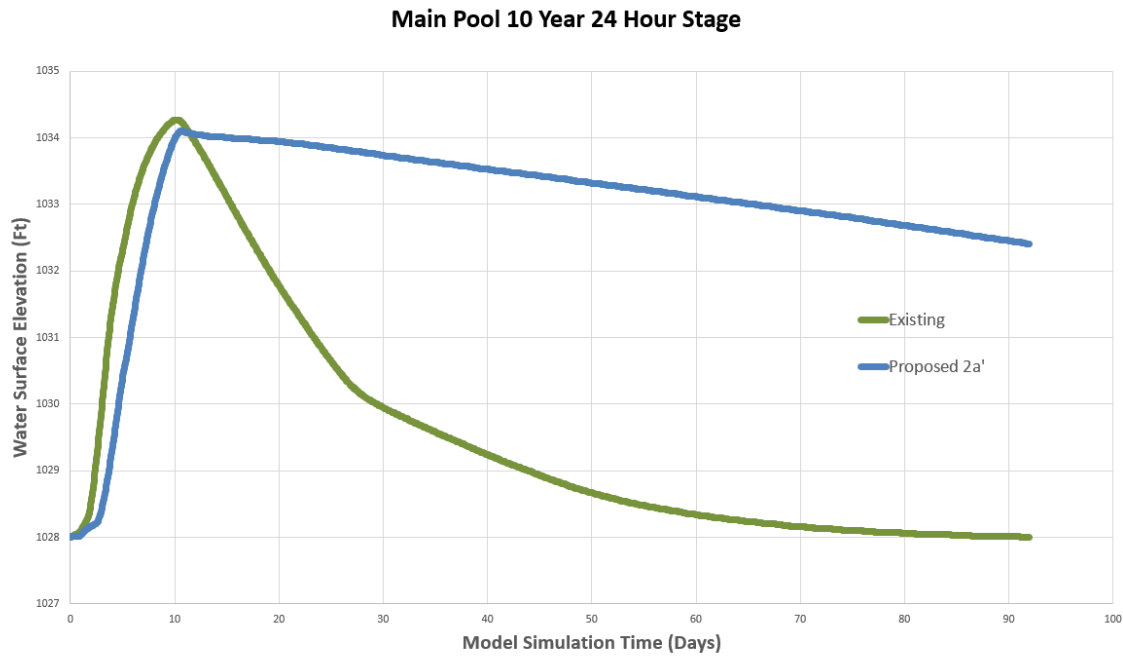
Figure 21. Existing Condition vs. 2a' Stage in Main Pool for the 10-year 24-hour event

Figure 21 shows the water surface elevation (stage) for existing conditions and Alternative 2a' in the main pool for the 2, 5, and 10-year 24-hr events. There is enough flow during the 10-year 24-hour event to fill the main pool to elevation 1034 resulting in a 94 cfs FDR benefit.

The embankment height, weir crest elevation, and gate operation impact FDR benefits. Once main pool levels are above the embankment height the storage area is inundated so there is no FDR benefit. Once the main pool level is above the weir crest elevation the project no longer changes flood storage from existing conditions so there is no new FDR benefit. A higher embankment and weir crest would provide the ability to send more flow downstream, but more flow downstream would create a downstream rise during the lower flow events.

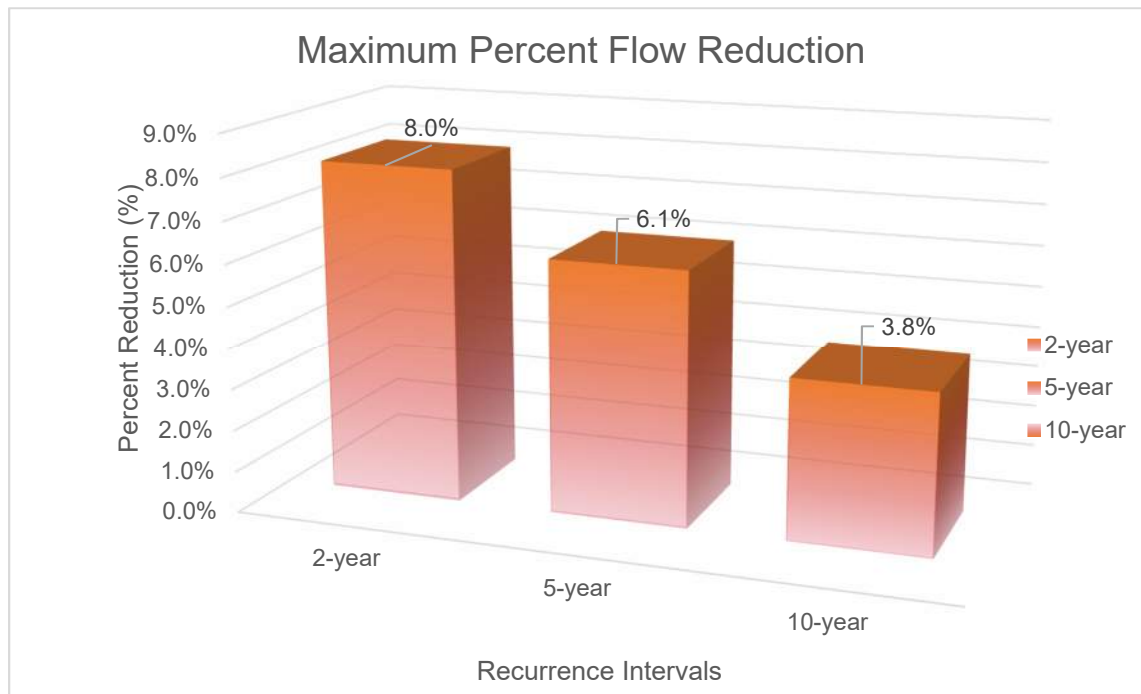
Figure 22. Maximum Percent Flow Reduction for the 2, 5, and 10-year events

Figure 22 shows the maximum potential percent flow reduction for the project for the 2, 5, and 10-year events.
