Detailed Survey Report

Roseau River Watershed District
Watershed Ditch #4

Roseau County, MN
September 7, 2022

HDR Engineering, Inc.

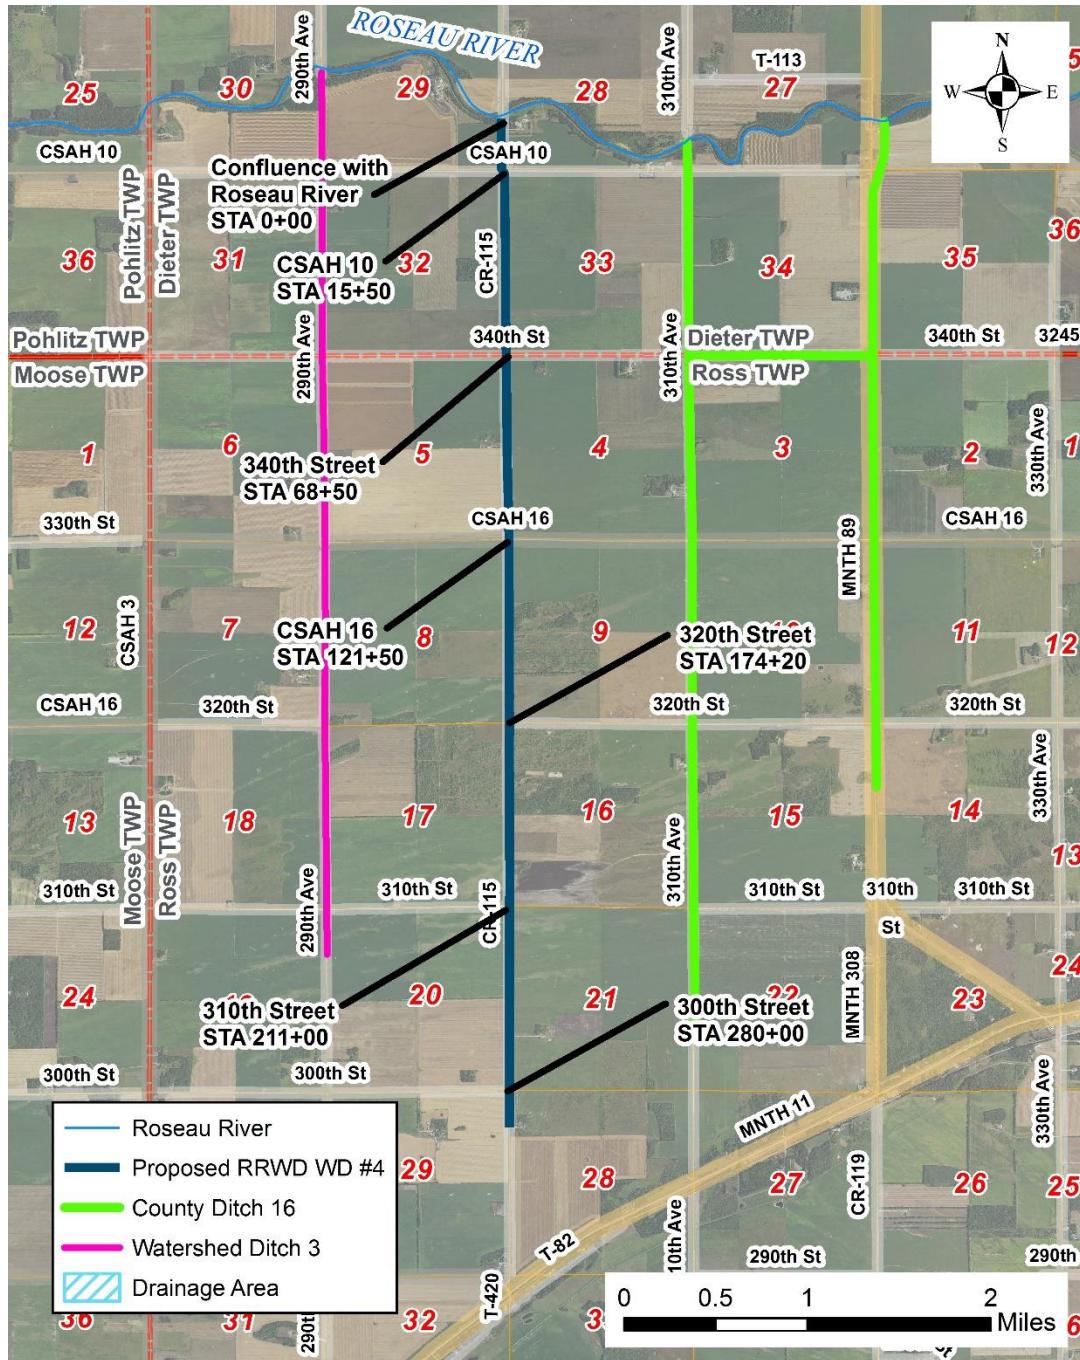
Figure 5. Roseau River Watershed District Watershed Ditch #4 Alignment and Stationing

The proposed alignment of WD 4 is displayed in Figure 5. Project stationing was set so that station 0+00 is located at the confluence of the Roseau River and the proposed WD 4.

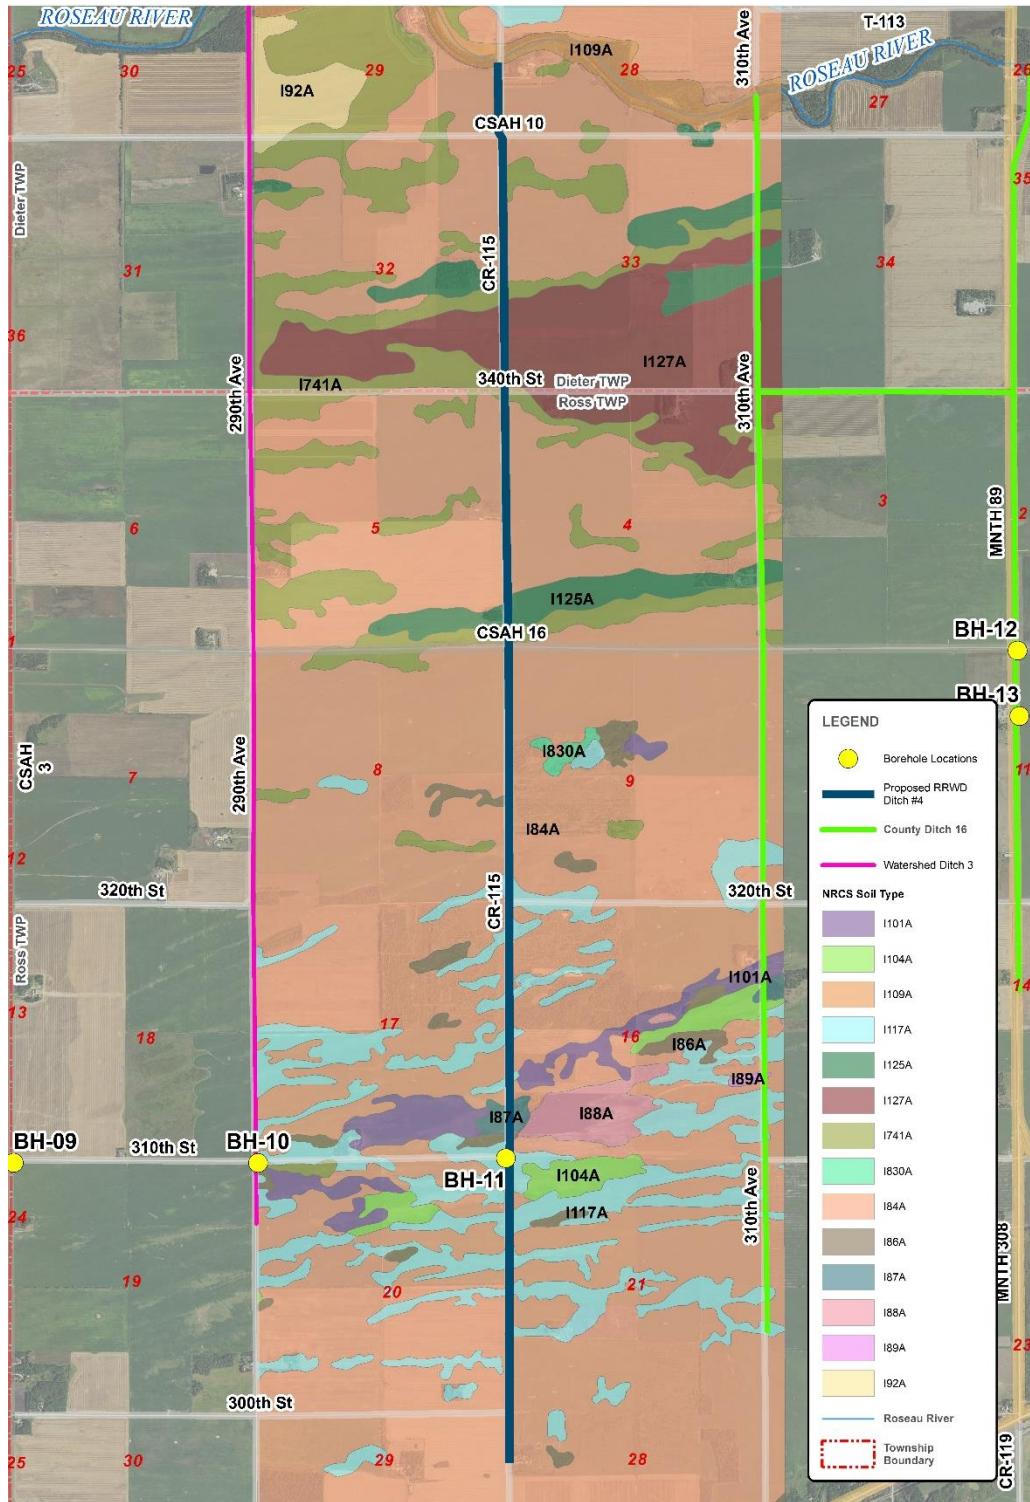
Figure 6. Roseau River Watershed District Watershed Ditch #4 Soils – NRCS Data

loamy. The major uses of these soils are cropland, hay, and pasture. The land is also frequently ponded.

One soil boring (BH-11) was completed at the south end of the proposed WD 4. The borehole data indicates that the soil at this borehole location is stiff to rather stiff lean clay to the maximum depth explored (31 feet). This data compares similarly to the soil survey data discussed above. Groundwater was not encountered during the borehole investigations. It should be noted that groundwater levels will fluctuate seasonally and in response to climatic conditions.

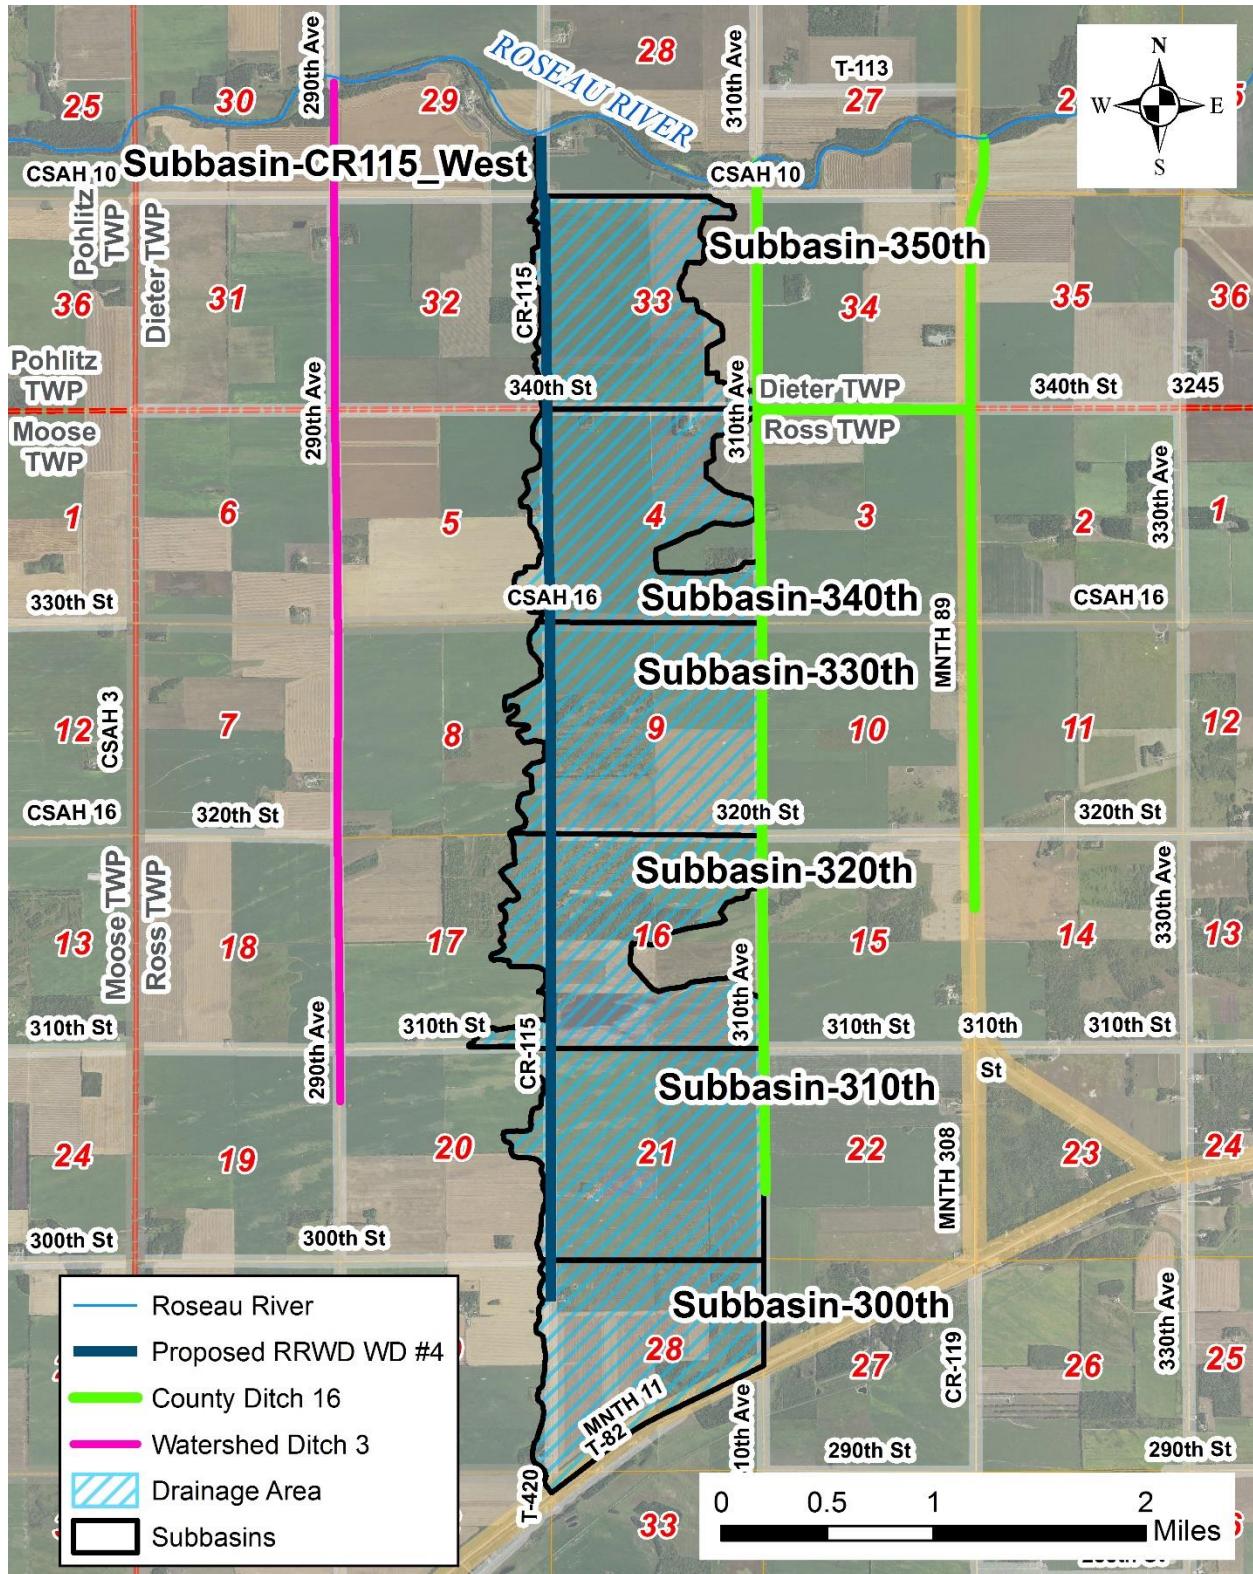
Figure 8. Subwatershed Drainage Areas

The proposed WD 4 drainage area was divided into seven subwatersheds with a total contributing area of approximately 5.7 square miles. The drainage area for each subwatershed is displayed in Figure 8 and Table 3.

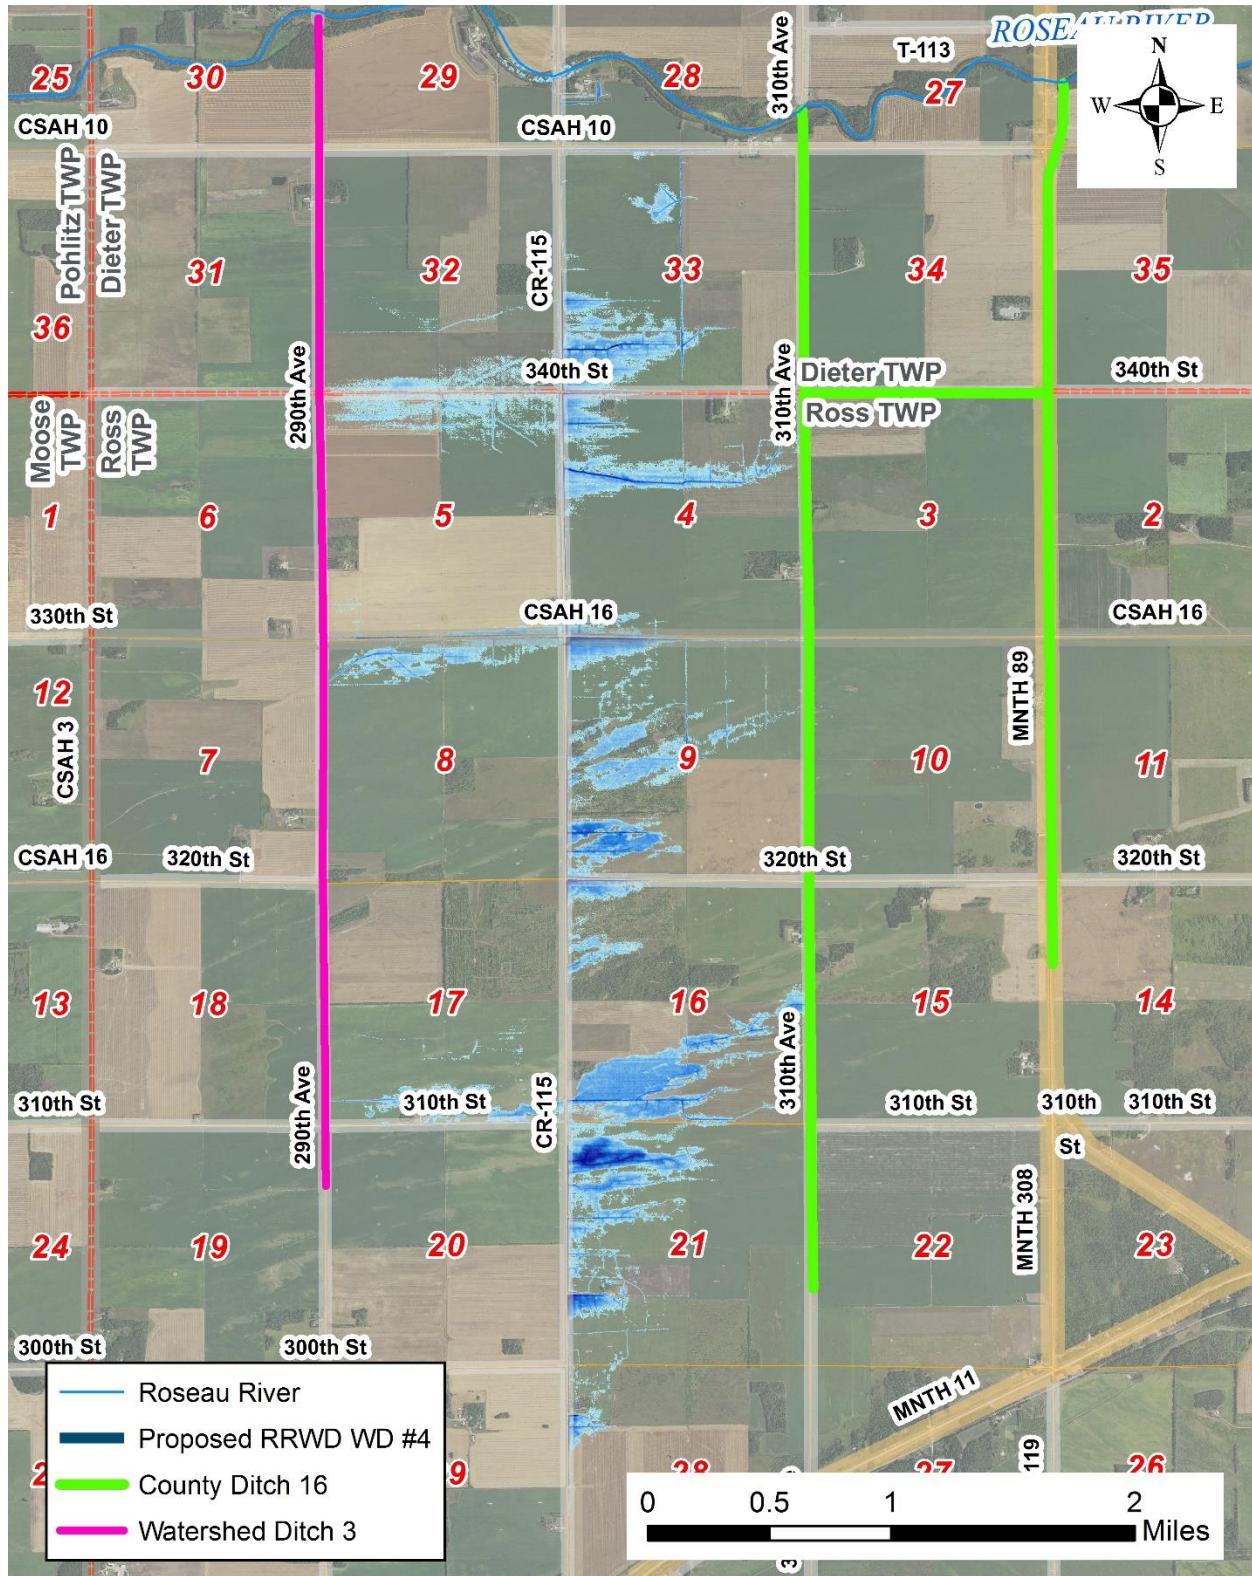
Figure 9: 10-Year 24-Hour Existing Condition HEC-RAS Flood Extents

Figure 9 displays the existing condition result from HEC-RAS for the CR 115 east roadside ditch during a 10-year 24-hour rainfall event. The system was modeled such that water was allowed to travel west through the four centerline culverts into the WD 3 drainage area. Hydrologic data was not input into the HEC-HMS model for the WD 3 drainage area so the flooding that occurs in Sections 5, 8, and 17 of Ross Township and Section 32 of Dieter Township would be greater than displayed.

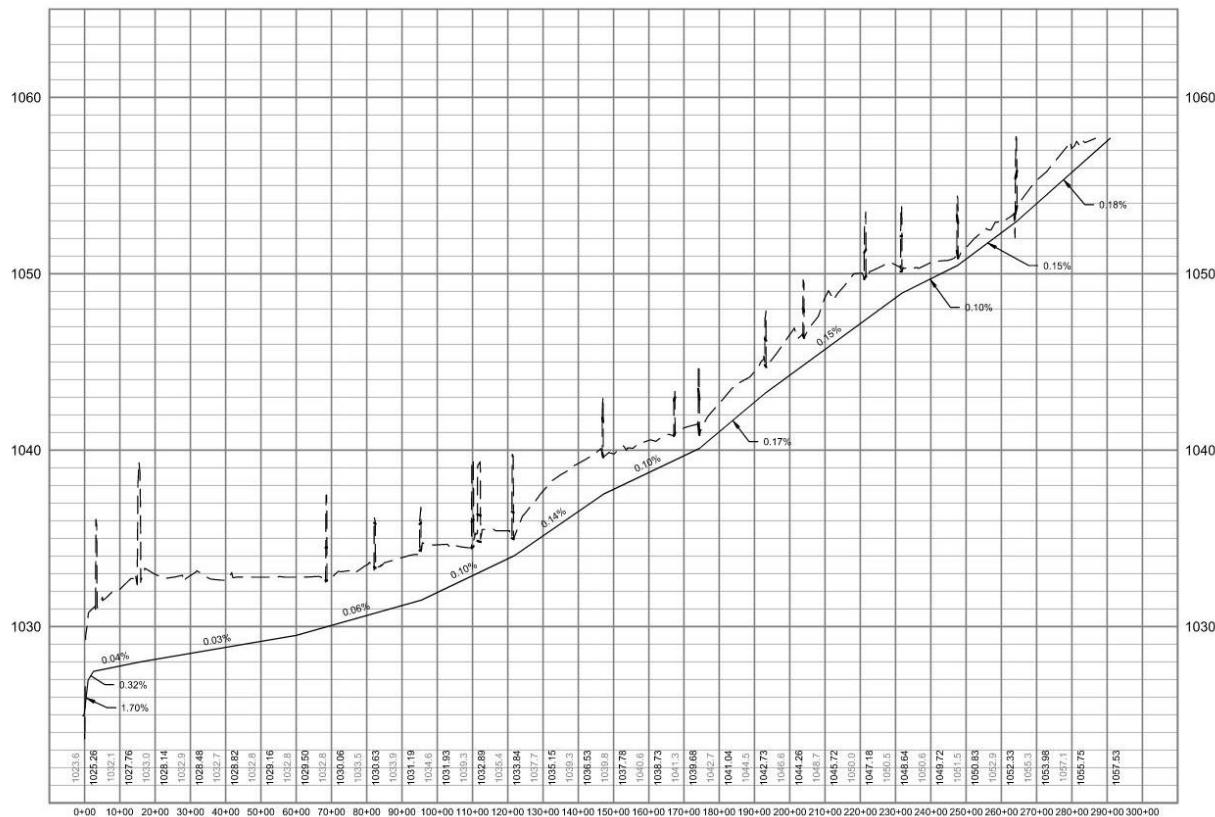
Figure 11: Proposed WD 4 Centerline Profile & Grades

| Stations | Proposed Grade |
|---|---|
| 247+72 to 264+50 | 0.15% |
| 264+50 to 290+80 | 0.18% |

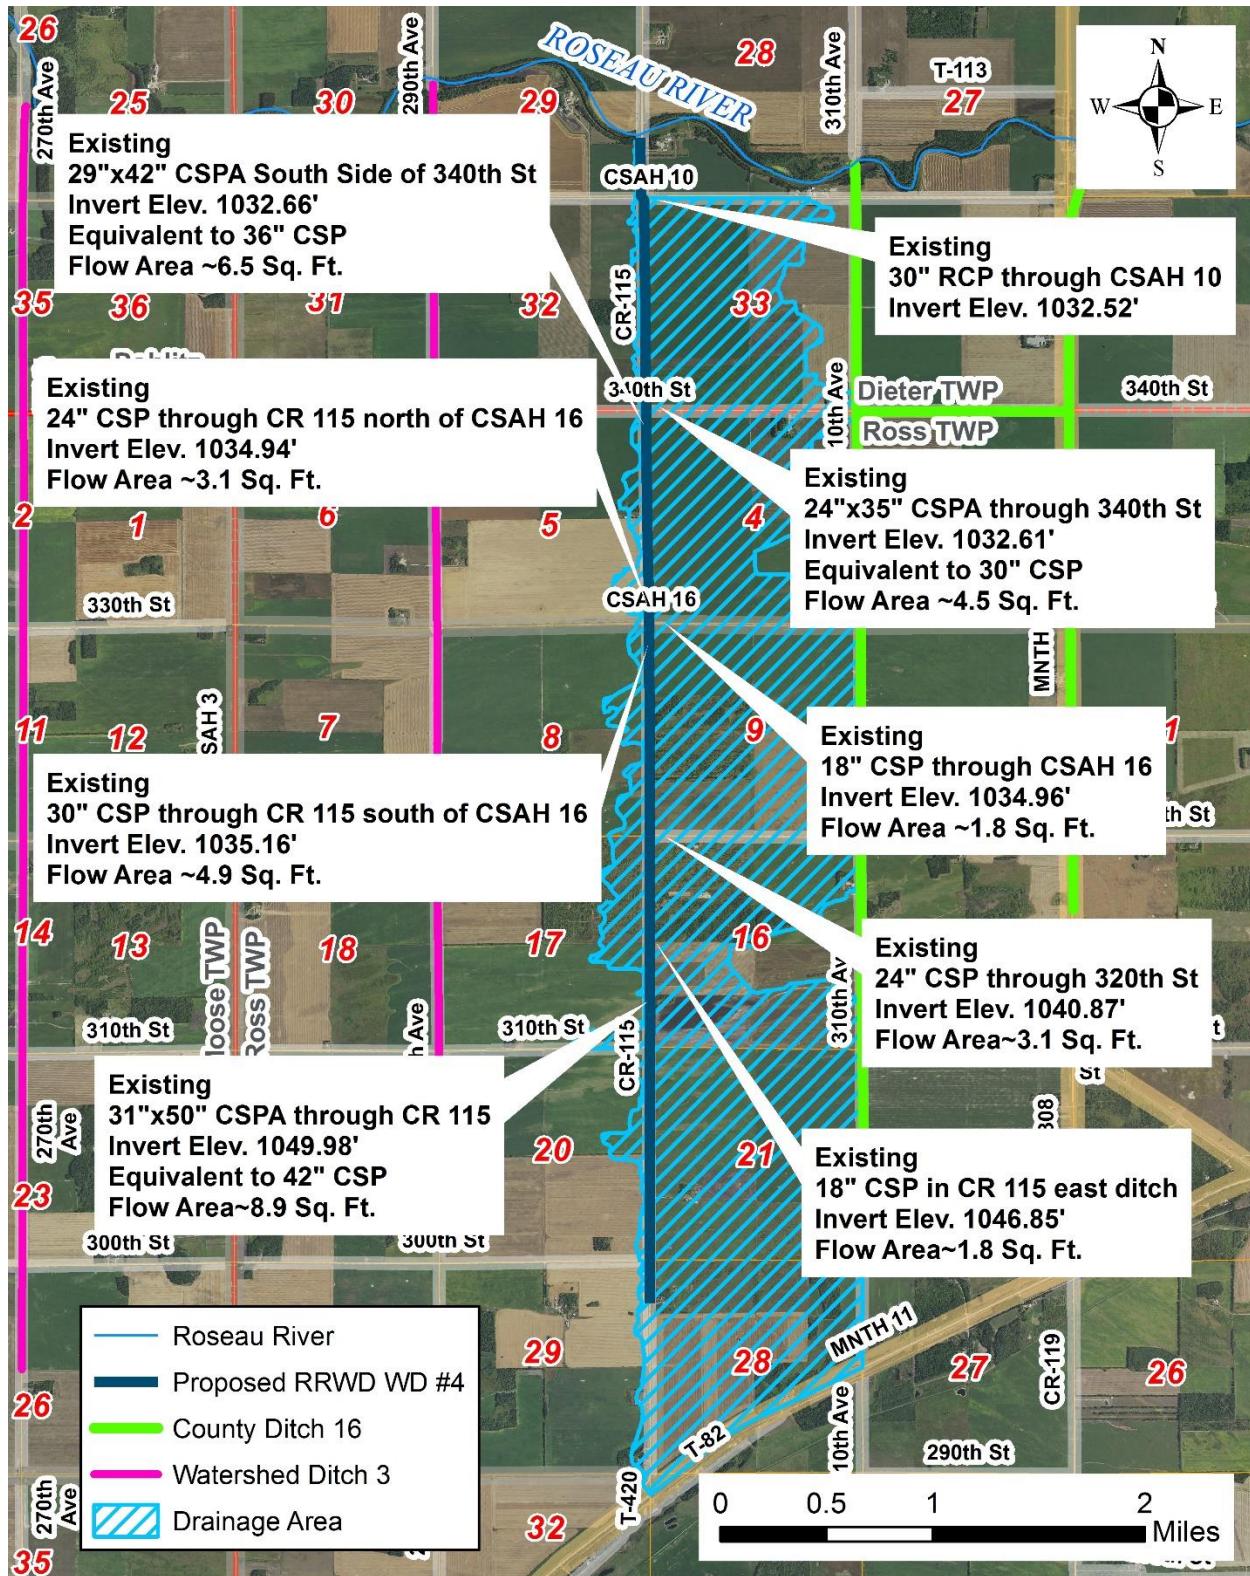
Figure 12: Existing CR 115 Centerline Culverts

A meeting was held with the Roseau County Highway Department on February 28th, 2022 to present the alternative of removing the culverts. The hydraulic results showed that runoff from up to a 50-year 24-hour would not overtop CR 115 with the proposed WD 4 in-place and the centerline culverts removed. This is assuming that the WD 4 system is functioning as designed and the Roseau River has the capacity to receive the runoff.

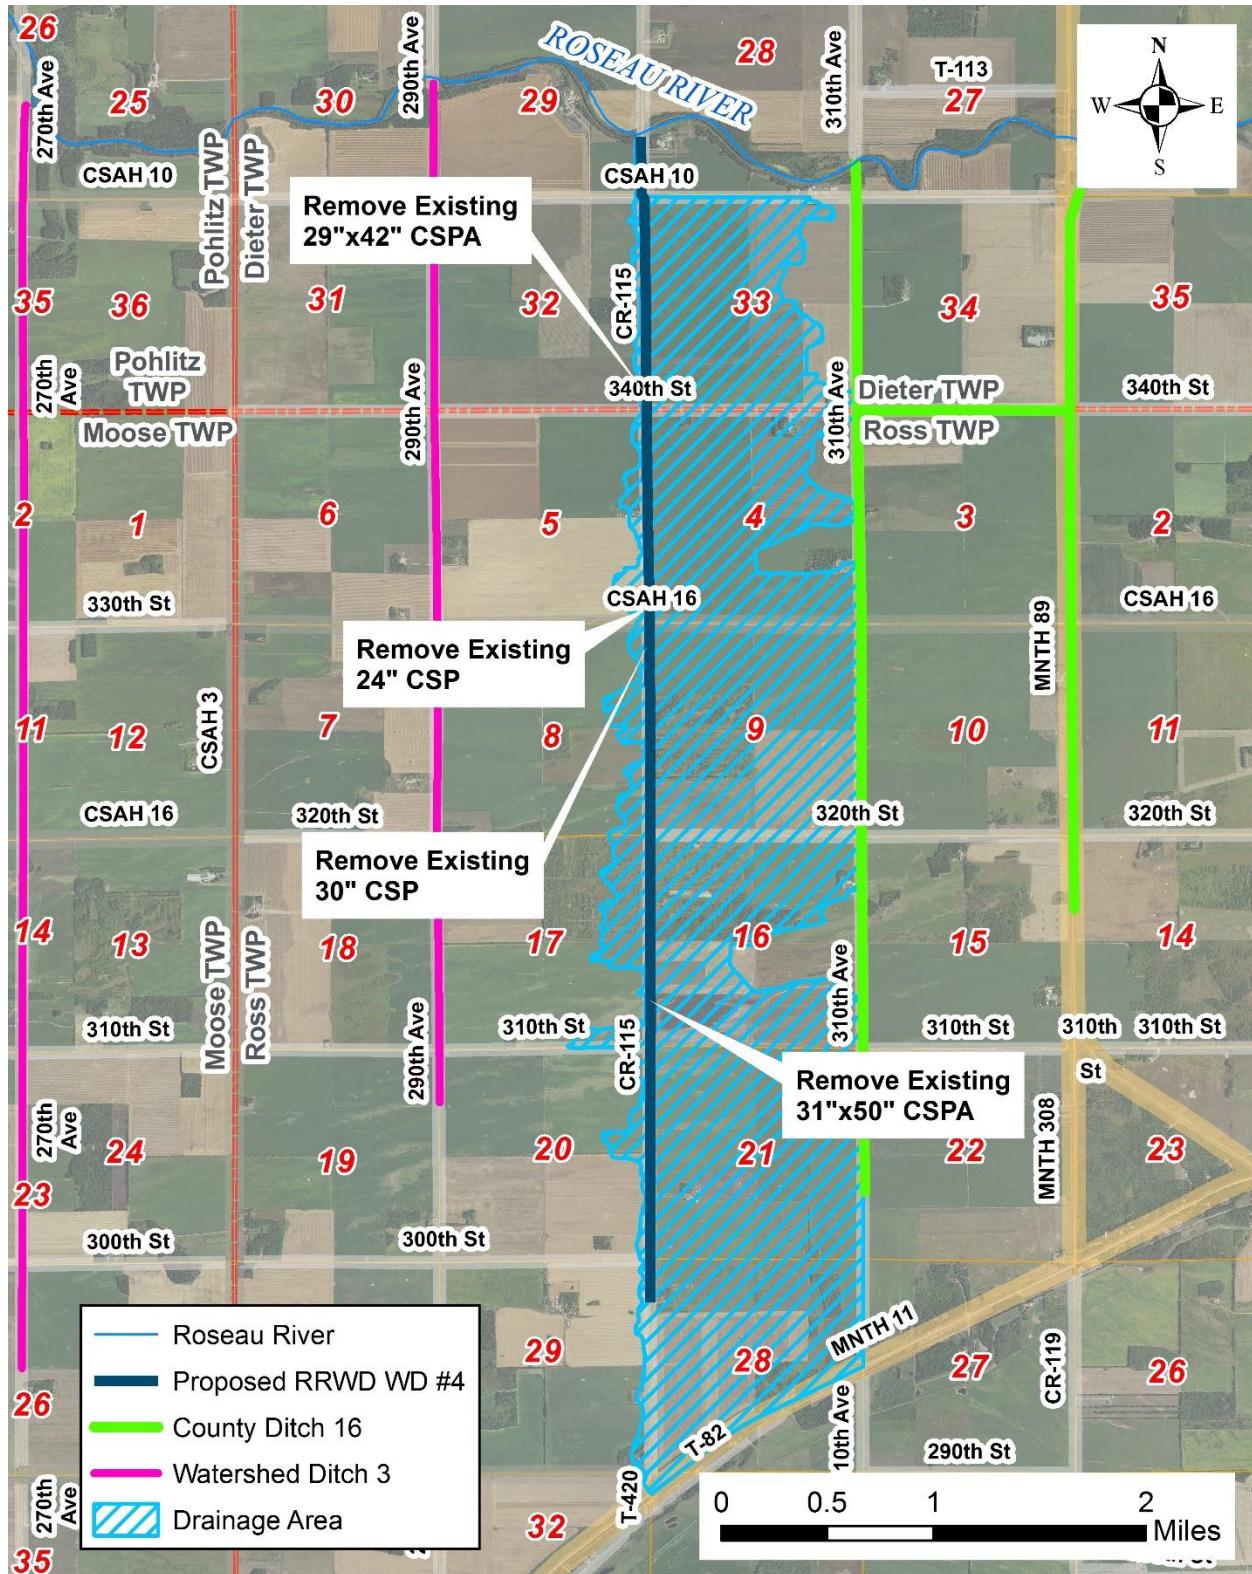
Figure 13: CR 115 Centerline Culverts to be Removed

Following the meeting, a permit was granted to the Roseau River Watershed District for the removal of the four CR 115 centerline culverts contingent upon construction of the WD 4 system. Figure 13 displays the four culverts to be removed during construction of the Project.

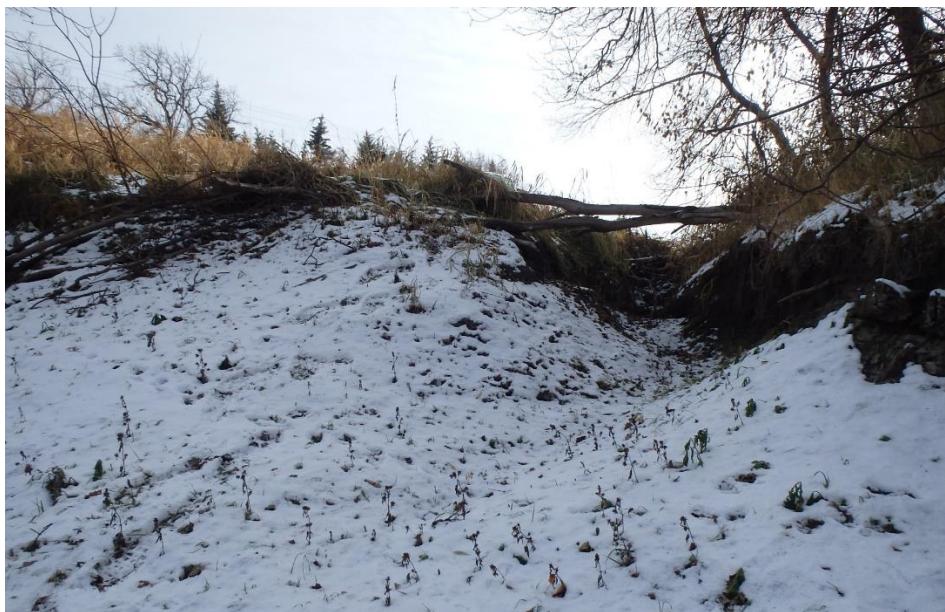
Figure 14: Existing Condition of Proposed WD 4 Outlet Location

WD 4 will discharge on the west side of CR 115 to the Roseau River. This location is currently experiencing head cutting and negative erosive impacts to the adjacent riverbank due to the sudden change in elevation as the ditch transitions to the River as displayed in Figure 14. Measures will be taken to stabilize this transition area and minimize adverse impacts to the riverbank, road slope, and bridge upstream of this location. Two rock drops consisting of Random Riprap Class 3 -Special are proposed to remove the steep grade transition. Any work that takes place below the ordinary high-water elevation of the Roseau River will require a MnDNR Public Waters Permit.

The project will have a positive impact on water quality. The existing ditch does not incorporate a grassed buffer area or frequent side water inlets. During the survey and site inspection it was observed that significant erosion occurred during runoff events. The proposed design incorporates the use of side water inlets and a minimum 16.5-foot grass buffer area. Flared end sections and riprap will be utilized to reduce velocities and prevent scour.

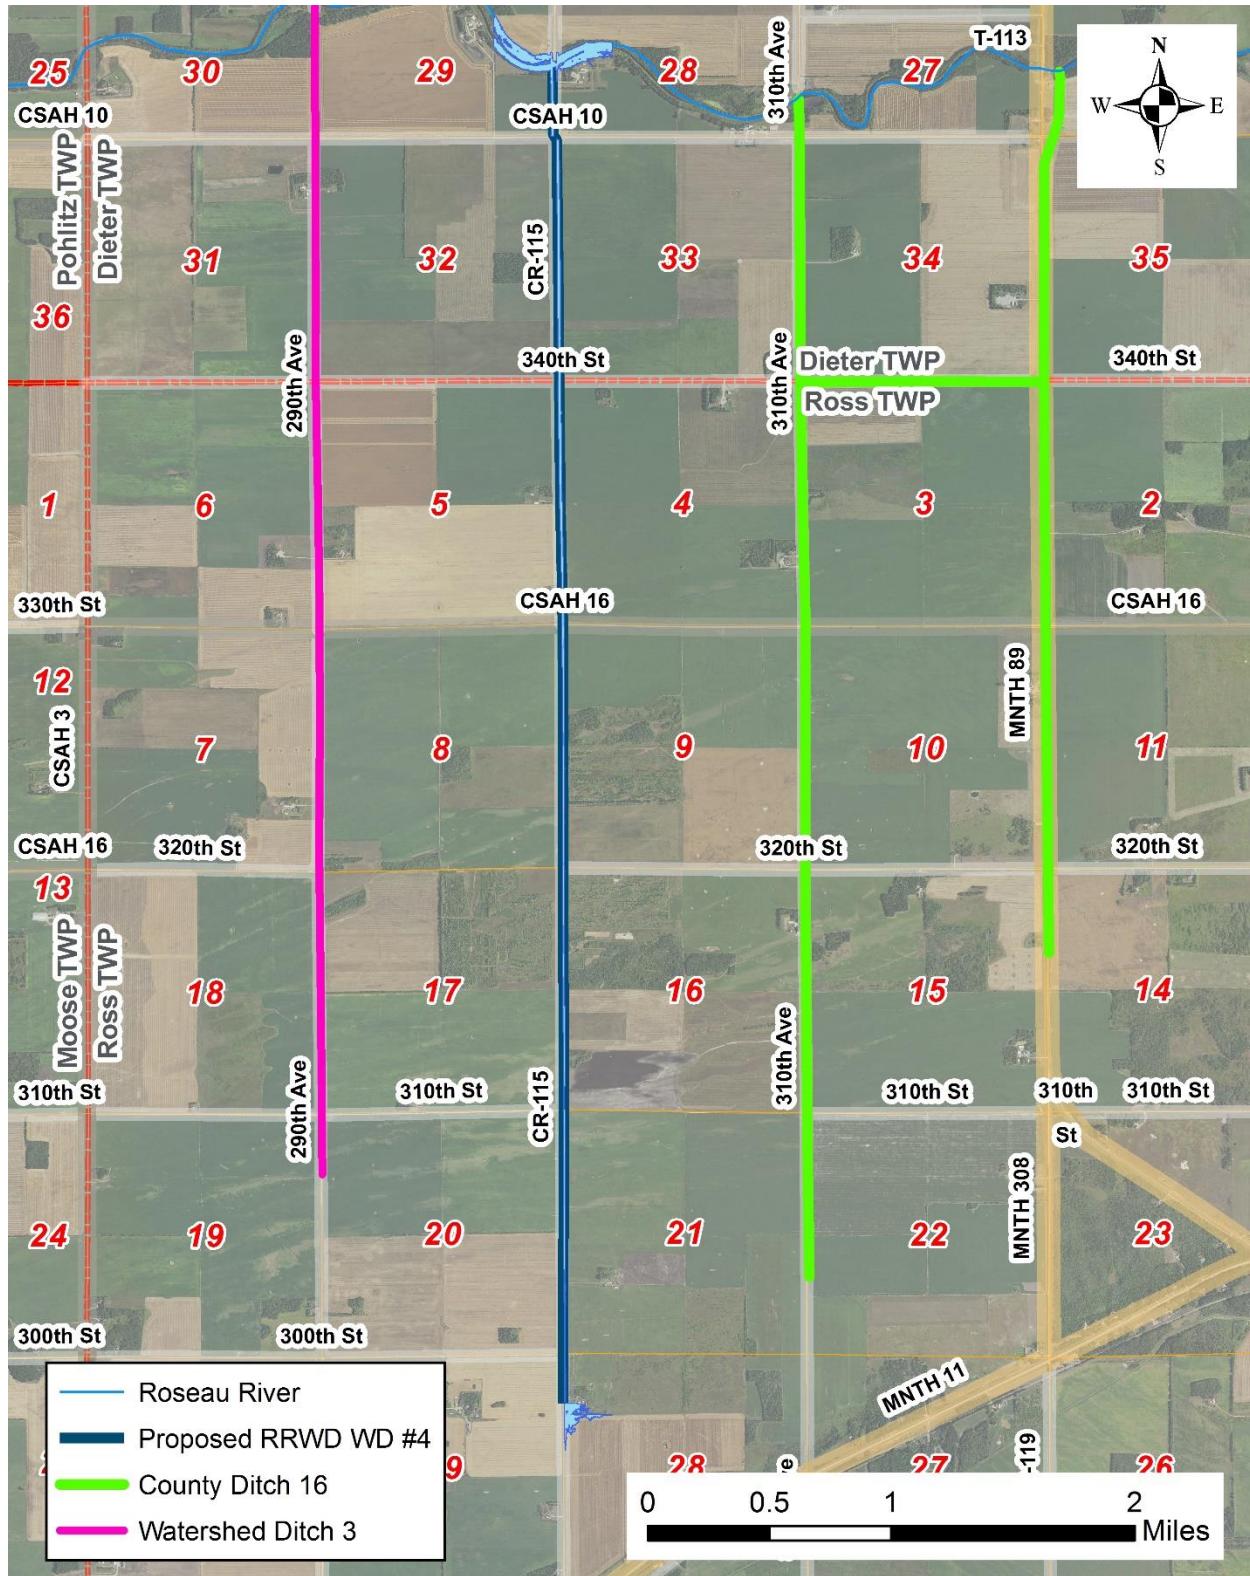
Figure 15: 10-Year 24-Hour Proposed Condition HEC-RAS Flood Extents

Figure 15 displays the proposed flood extents for the 10-year 24-hour rainfall event when the Roseau River is at normal summer stage. The proposed design has the capacity to convey the 10-year event with minimal breakouts occurring where the proposed ditch limits tie into the existing roadside ditch at the upstream extent of the Project area. The peak water surface elevation is above the adjacent landscape in several locations along several reaches of the ditch and when that occurs, the spoil berm contains the flows.

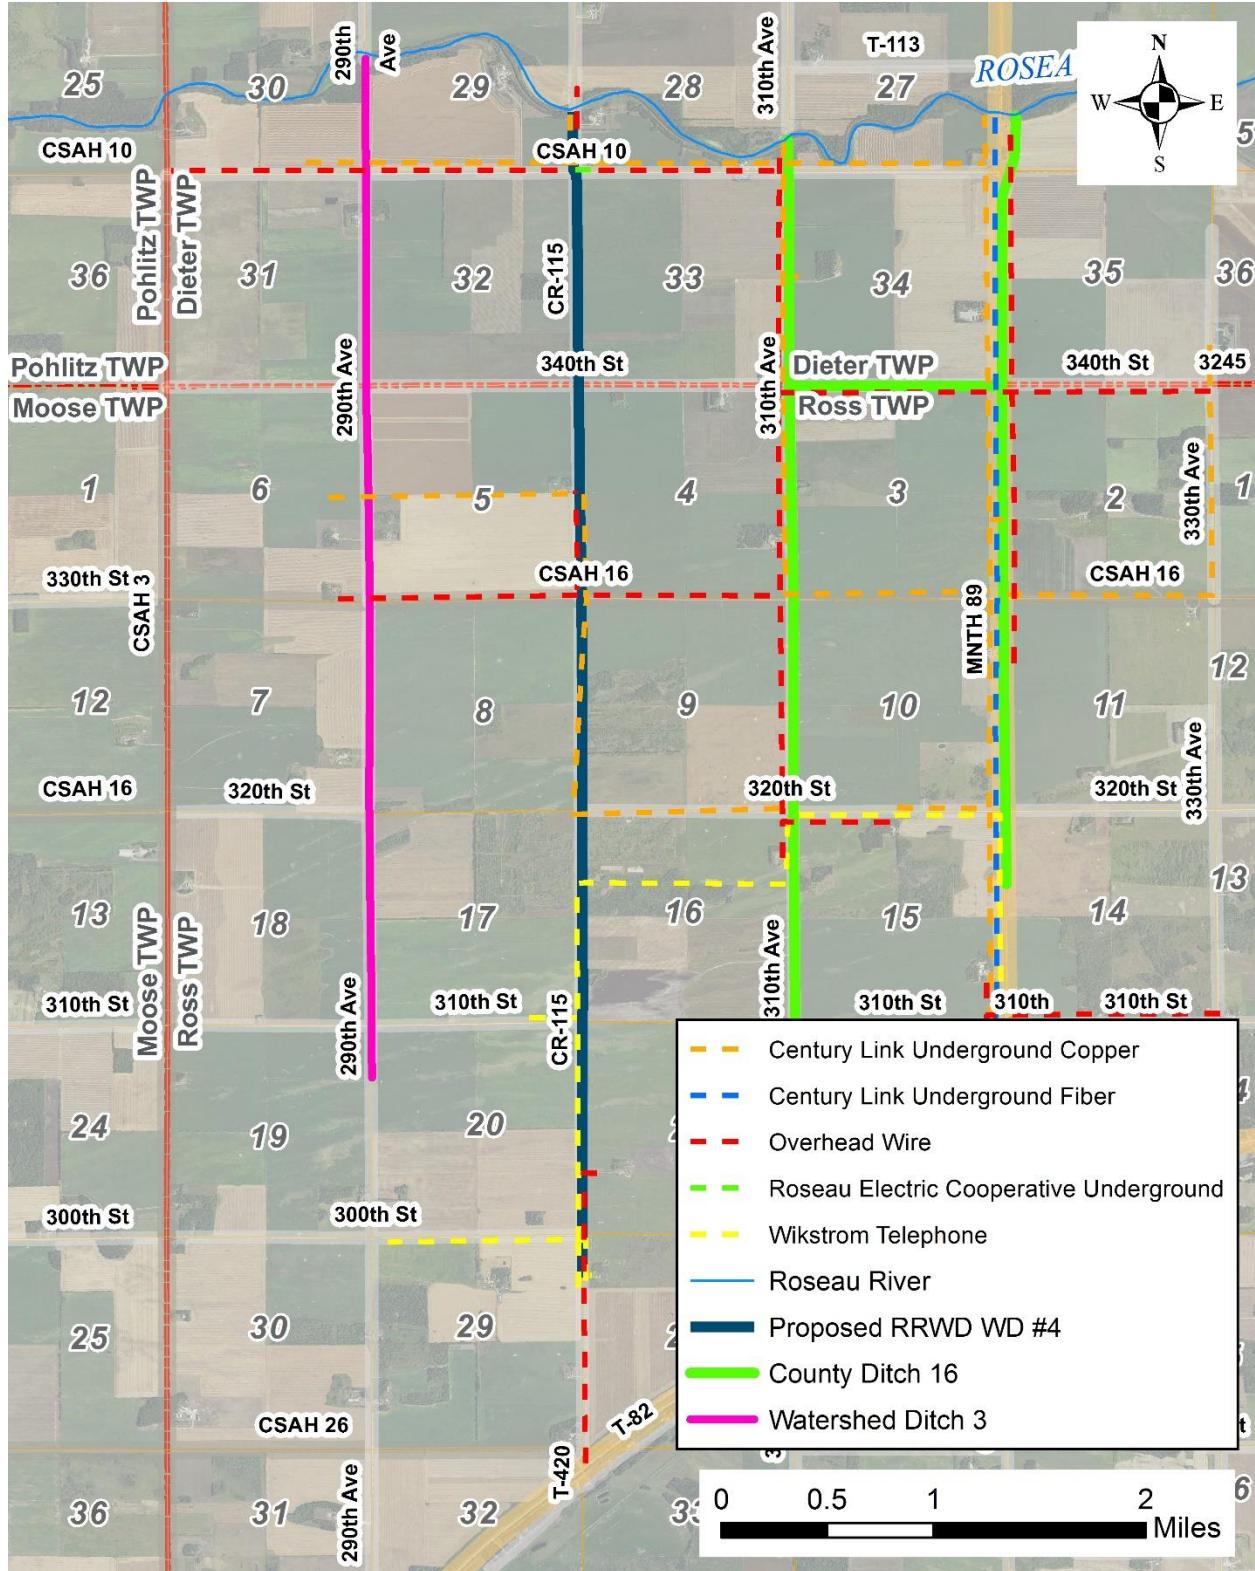
Figure 16. Existing Utilities

HDR conducted a Gopher State One Call to obtain information on what utilities are located inside the project area. The known utilities within the project area are shown in Figure 16. Exact locations of other utilities such as fiber optic, water lines, and underground electric crossing the ditch will also be determined during development of the construction documents.

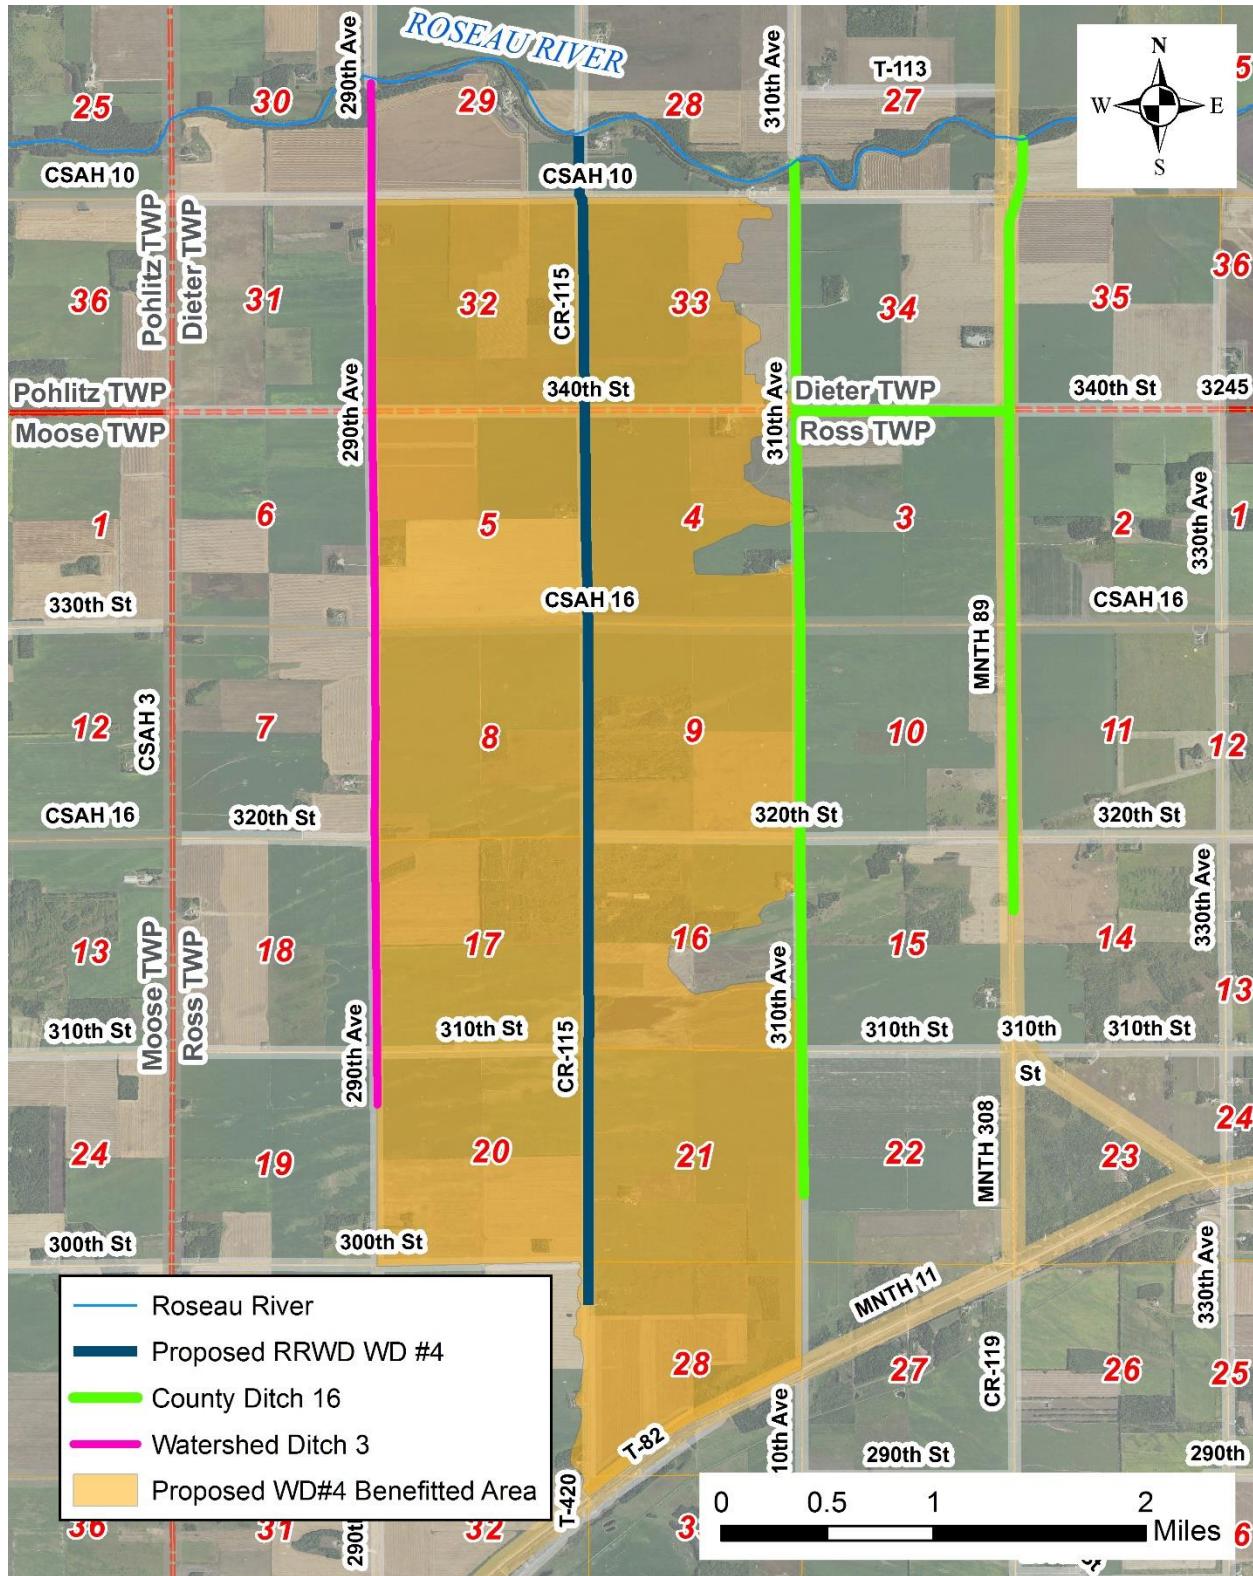
Figure 17: Proposed Watershed Ditch 4 Benefitted Area

An independent group of viewers were appointed by the Roseau River Watershed District on May 6th, 2021 to analyze the drainage benefits that the proposed WD 4 Project would have on the lands within the drainage area. Through landowner meetings and discussions with RRWD staff, design changes were proposed which were to remove all four centerline culverts through CR 115. The four existing centerline culverts through CR 115 convey water from east to west during all runoff events into the WD 3 system. A landowner meeting was held on February 9th, 2022 to discuss these changes with the landowners within the WD 4 drainage area and those east of WD 3. The landowners in attendance and the Roseau County Highway Department engineering staff were in favor of this change if it would not negatively impact the efficiency of the proposed WD 4 system or the adjacent roadways. The removal of the culverts extends the benefitted area from the WD 4 drainage area to Section 32 of Dieter Township and Sections 5, 8, 17, and 20 of Ross Township immediately adjacent to the west of County Road 115. The proposed benefitted area for WD 4 is displayed in Figure 17. The Detailed Viewer's Report Exhibit 1 can be found in Appendix G. The exhibit provides the proposed benefit values by 40-acre tracts for each of the parcels within the proposed WD 4 benefitted area. It also outlines the damages for each 40-acre tract for the parcels adjacent to the proposed alignment.

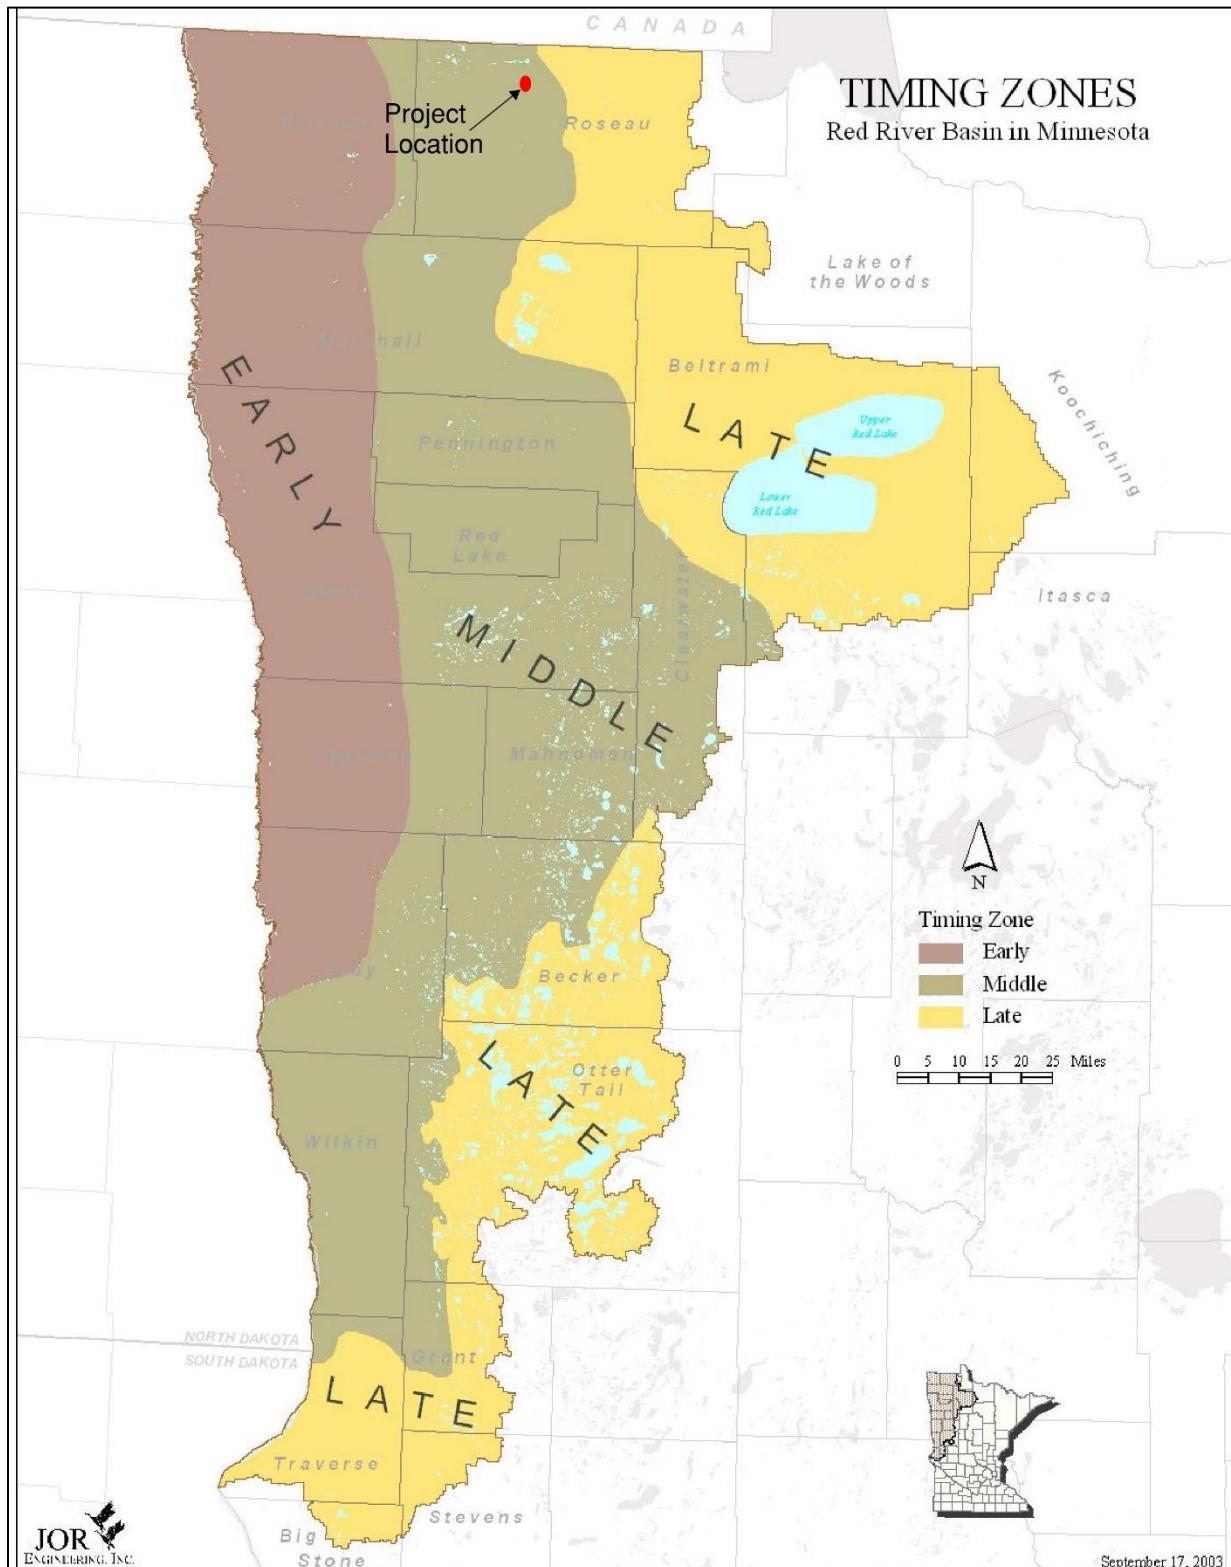
Figure 18. Runoff Timing Zones

The outlet for the proposed drainage system establishment is the Roseau River. During major flood events, almost all areas of the RRWD contribute flood water to the Roseau River. However, due to location or other characteristics, some areas may consistently contribute more to the peak flow which is the more damaging portion of a flood hydrograph. The selection and design of appropriate Flood Damage Reduction (FDR) measures will depend on the timing of an area's flood water contribution to flooding in other areas of the basin.

The Project is consistent with the Mediation Agreement goals adopted by the RRWMB and Red River Basin Flood Damage Reduction Work Group. The flood water is considered to be "early water" for the Roseau River and is in the middle area for the Red River of the North based on the Flood Damage Reduction Work Group Technical Paper #11. Figure 18 displays the three timing zones for the Red River Basin. FDR measures such as culvert sizing receives a positive "+" rating for a middle area. The drainage system is designed to improve drainage for runoff events up to a 10-year 24-hour storm duration when the Roseau River is at normal summer stage. Larger runoff events will result in water temporarily stored on the landscape. When a 2-year 24-hour event occurs throughout the RRWD, backwater from the River will enter the proposed ditch system as it does today without the Project.

Note that the timing of an area's flood water contribution depends on the location of the downstream damage center being considered. Knowledge of the timing of flows within the RRWD and the Red River Basin continues to be developed based on gage data from actual flood events and by hydrologic modeling.
