Detailed Survey Report

Roseau River Watershed District
Watershed Ditch #4

Roseau County, MN
September 7, 2022

HDR Engineering, Inc.

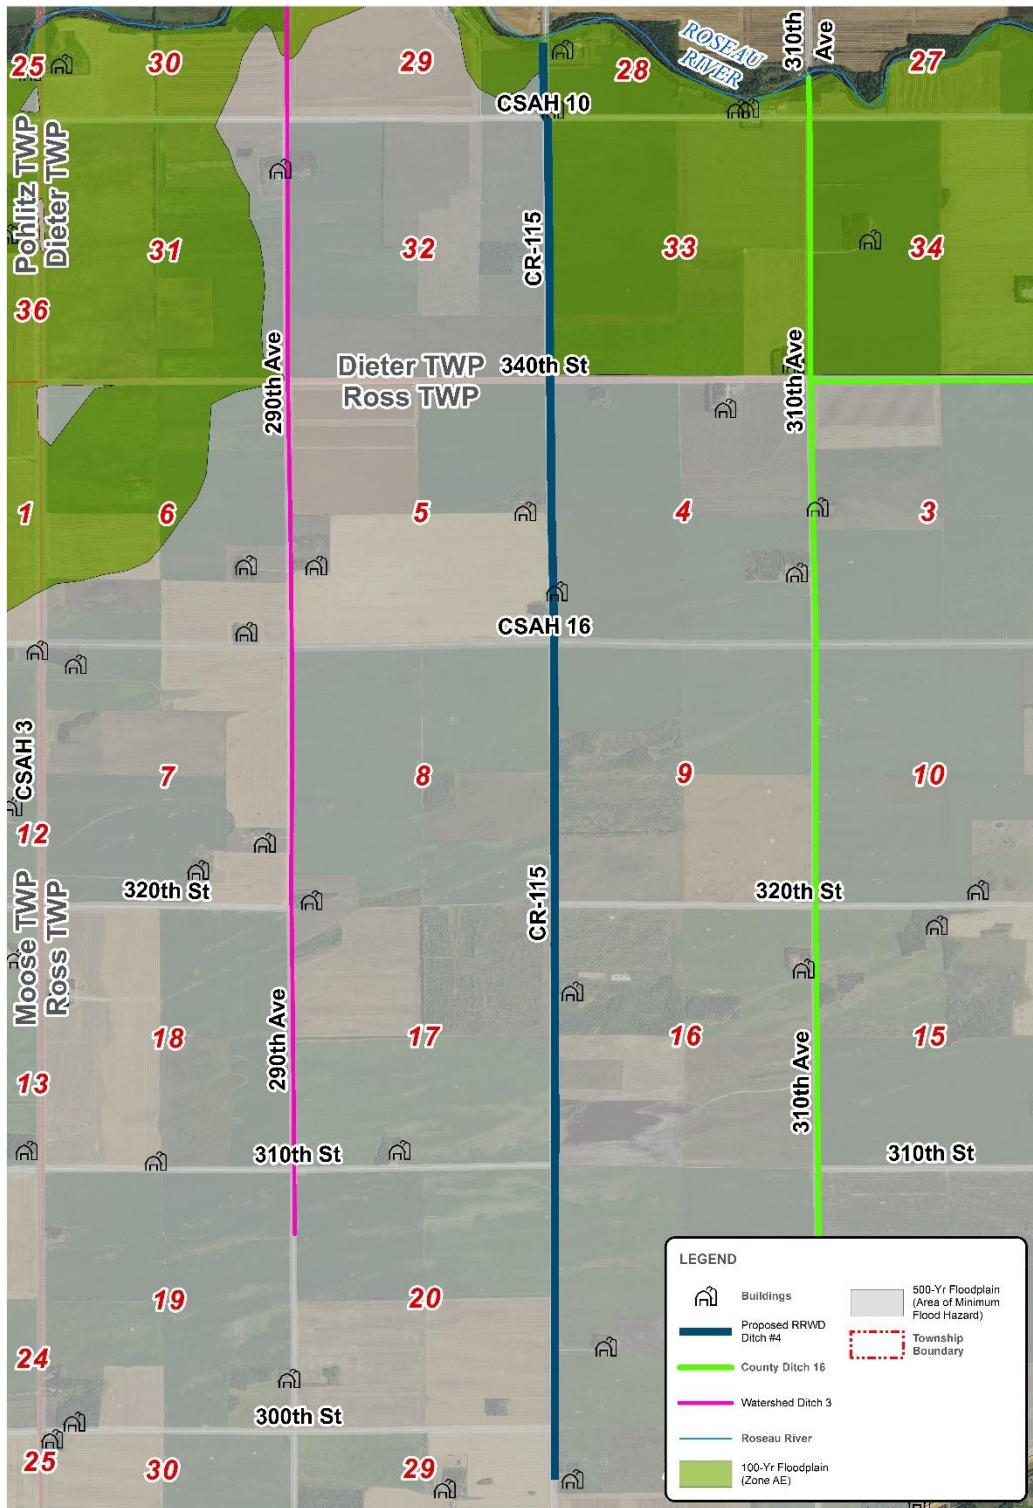
Figure 20. FEMA Floodplain Map

The Federal Emergency Management Agency categorized the northern portion of the proposed WD 4 (Sections 28, 33 and the northern portion of 29 of Dieter Township) as a Special Flood Hazard Area Zone AE (areas that have a 1% probability of flooding every year, also known as the "100-year floodplain). A permit is required before construction or development begins within any Special Flood Hazard Area to ensure that proposed development projects meet the requirements of the National Flood Insurance Program and the community's floodplain management ordinance. Figure 20 shows the FEMA floodplain in the location of the proposed WD 4.

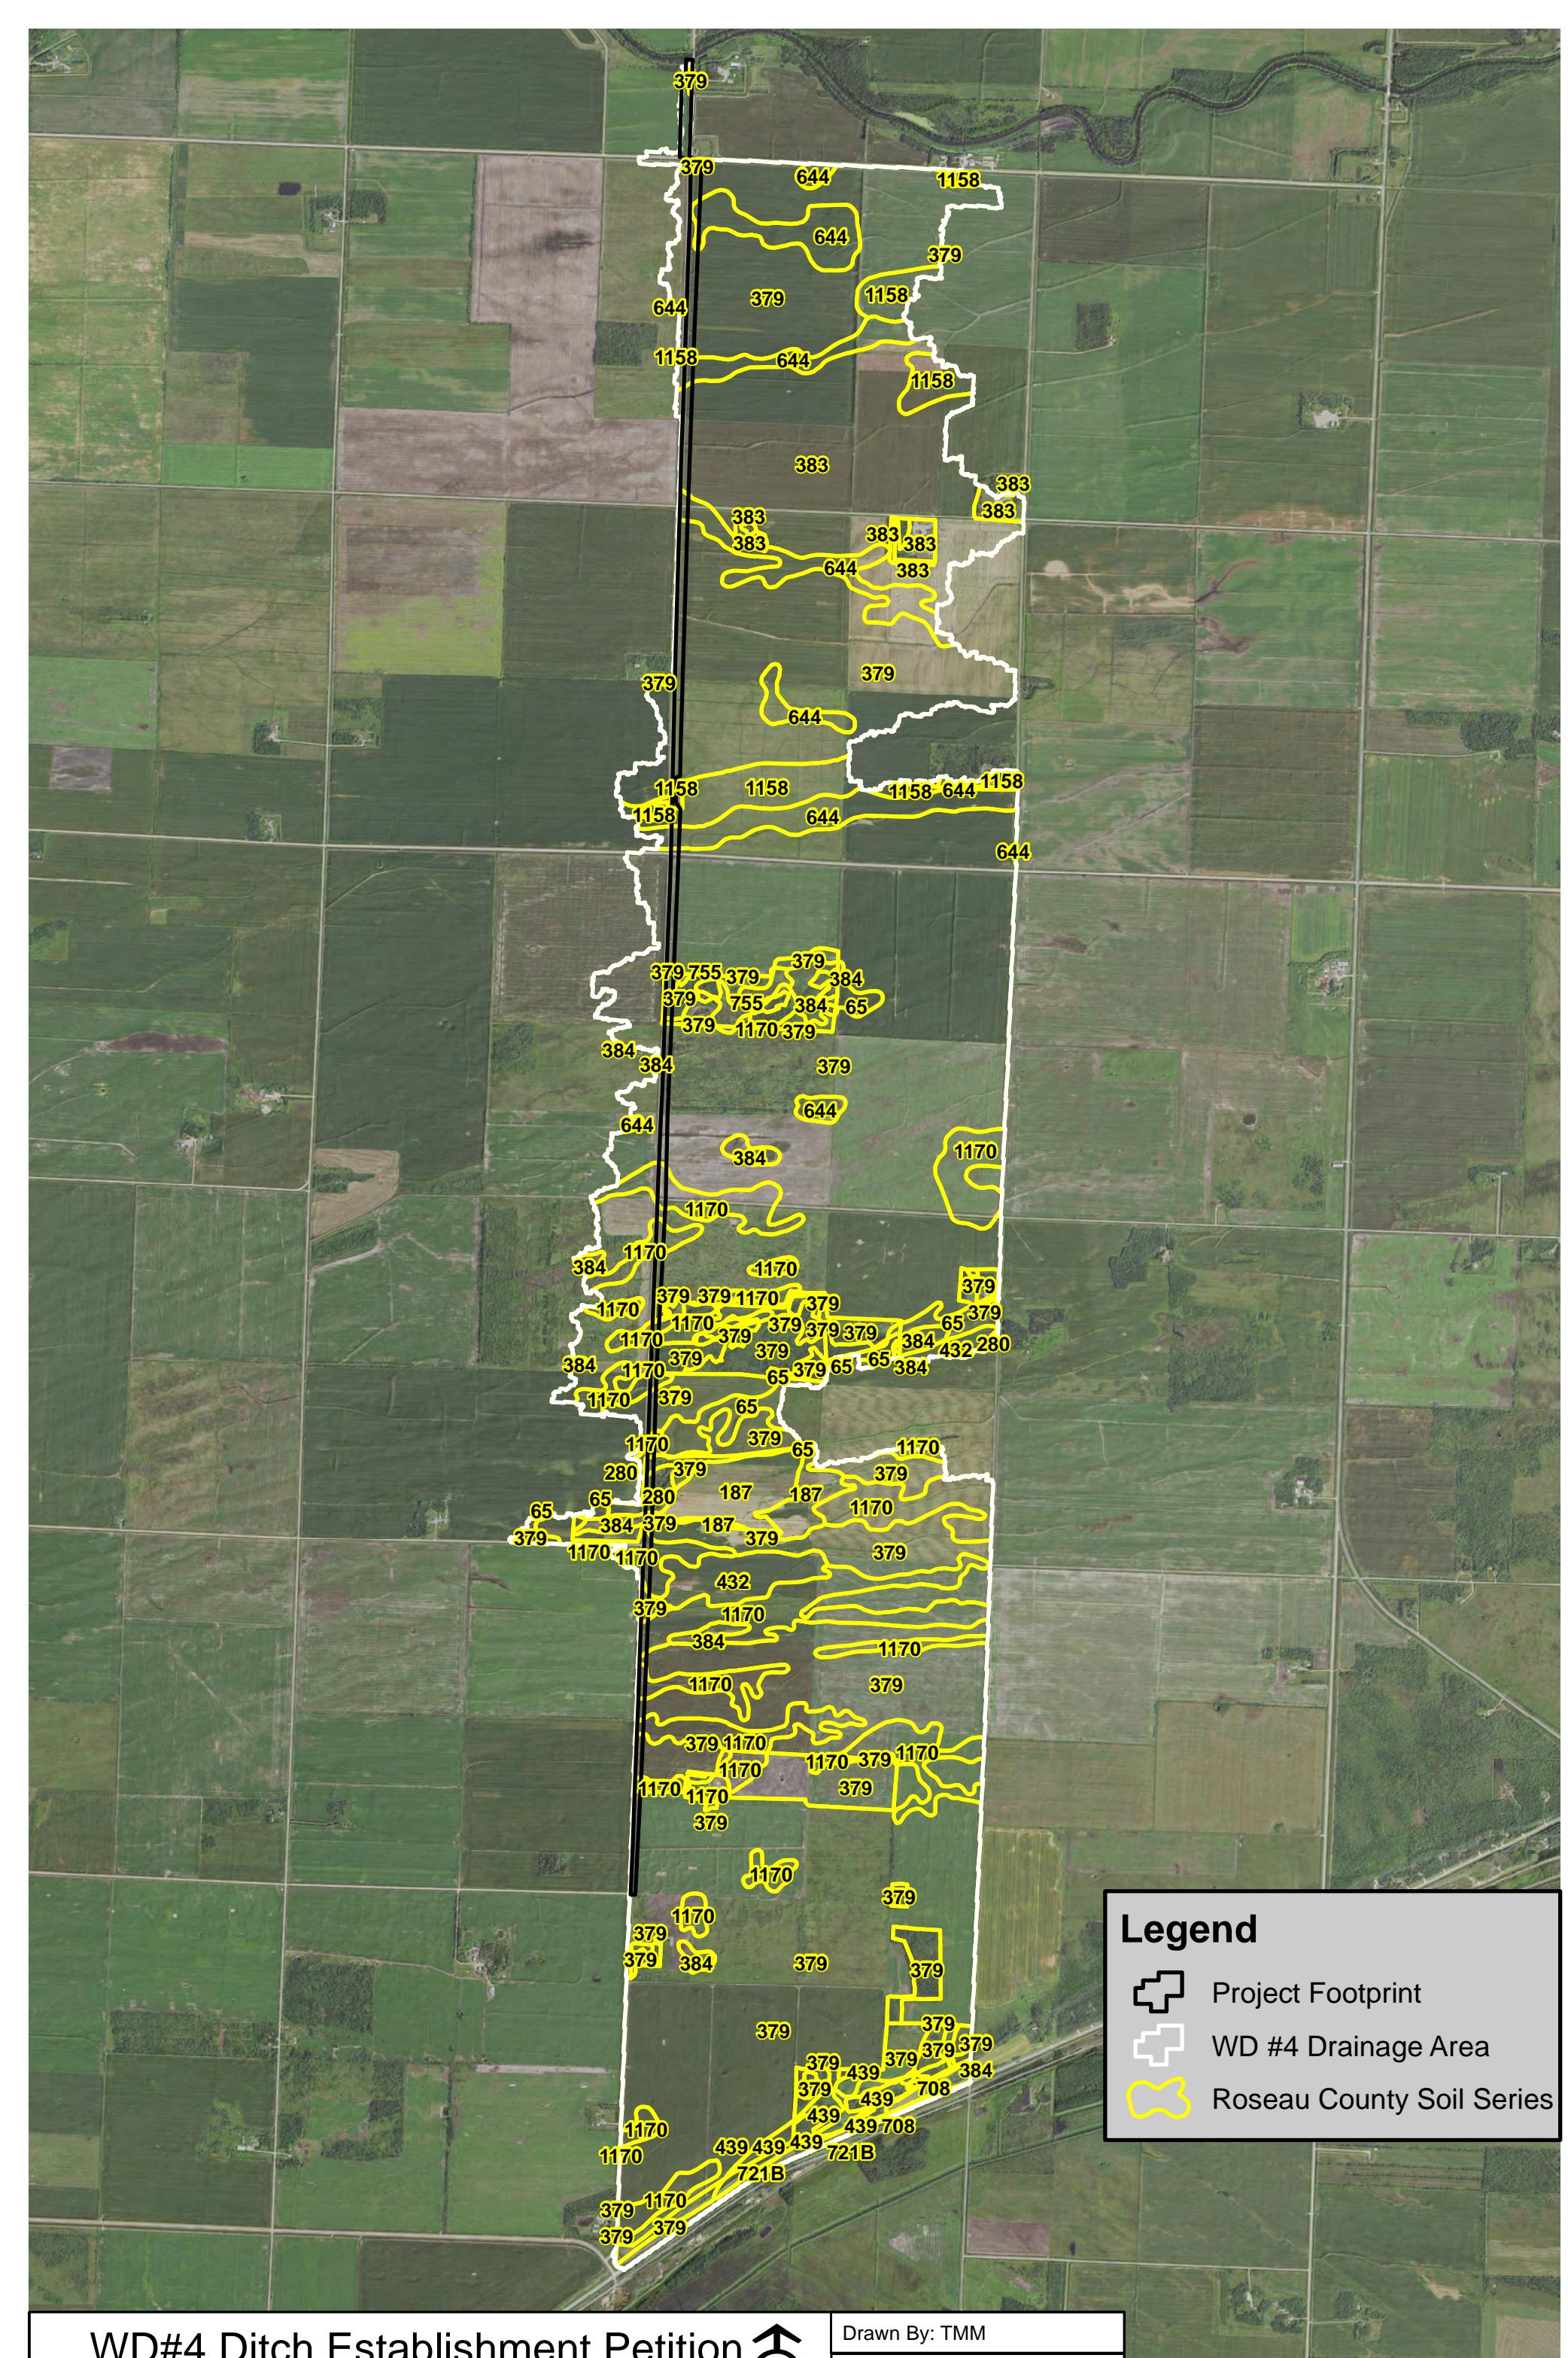
Figure 5
Roseau County Soil Survey Map

Soils within project area have developed from loamy lodgment till deposits on flats and till formed lake plains, in accordance with the Roseau County Soil Survey 1942. Soils data can be found in the Soil Survey Map (See Figure 5),
